REVISION 003  
dated Sep 24/25

## SB 25-1111432

## **SERVICE BULLETIN**

#### **Information Regarding the Potential Failure of the Guarded Rotary Buckles with Plastic Handles PNR 1111430-XX and PNR 1111475-XX**

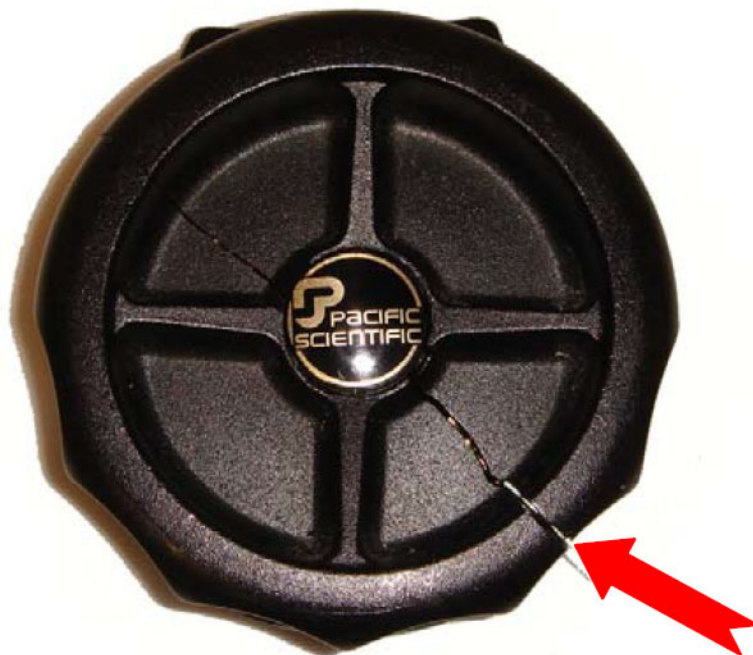
**Figure 1**  
*PNR 1111430-XX and PNR 1111475-XX Suspect Buckle Assembly*

- (1) SUMMARY :
  - (a) This SB informs operators that for a limited manufacturing time period, the guarded rotary buckle plastic handles (specific configurations of PNR 1111430-XX and PNR 1111475-XX) were susceptible to cracking.
  - (b) Parker Meggitt received field reports in 2006/2007 of several instances of cracking on the guarded rotary buckle plastic handle. The buckle assemblies were returned to and examined by Parker Meggitt had large, readily apparent cracks throughout the plastic buckle handle.
  - (c) After the initial incidence, there have been no indications of reported field failures. The condition has only appeared as infant mortality.

- (a) In review and analysis of the evidences and data gathered from the investigation, Parker Meggitt had determined that this cracking is caused by a material process issue, and suspect handles are subject to removal from service in 2007.

- (a) Based on the analysis, Parker Meggitt had concluded that cracked plastic handles indicates that in some circumstances when a load is placed on the

restraint system, the straps may not release as intended when the buckle is rotated. Parker Meggitt recommends the immediate replacement of the affected buckle assemblies.

NOTE 1 : Suspect handles may also be identified by measuring the thickness of the handle vane. Refer to Figure 1 as an example of a suspect buckle assembly with a crack.

NOTE : Any buckle assemblies with a cracked handle vane should be removed from service immediately.

- (1) Remove and replace the restraint system with a spare.
- (2) Refer to the paragraph 4.D. and 4.E. for disassembly and assembly of restraint system to repair the removed restraint system :
  - (a) Remove the buckle assembly in accordance with Figure 6 on page 23.
  - (b) Replace the suspect buckle assembly with a new and compliant unit.
- (3) For repair of buckle assemblies or restraint systems, send affected units to one of the following locations for replacement. Refer to Table 3.
- (4) For assistance with engineering inquiries, contact [sso.technical@support.parker.com](mailto:sso.technical@support.parker.com).
- (5) For assistance with technical publications inquiries, contact [sso.techpubs@support.parker.com](mailto:sso.techpubs@support.parker.com).

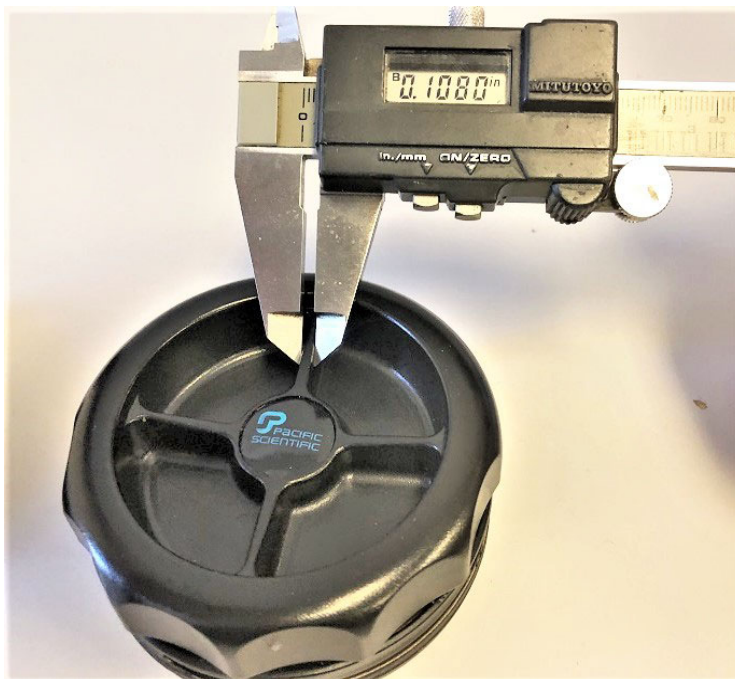
**Figure 3**  
*Correct Buckle Measurement*

- (2) If the thickness of the handle vane is greater than 0.125 inches at the top edge, then the buckle assembly is not compliant to FAA AD 2021-07-13 per AMOC dated June 29, 2021.

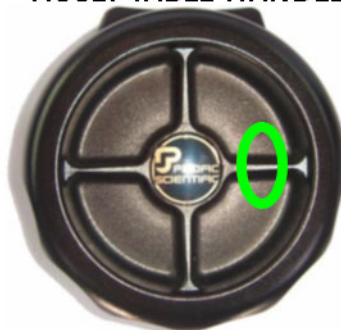
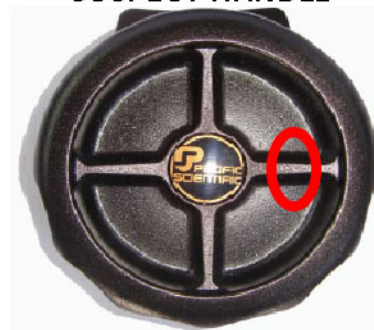
**Figure 4**  
*PNR 1111430-XX and PNR 1111475-XX Suspect Buckle Assembly*

- (d) Inspect the buckle for one or more of the following conditions :
- 1 The thickness of the handle vane is greater than 0.125 inches at the top edge
  - 2 The buckle assembly is cracked
  - 3 The buckle assembly is not cracked, but contains a GOLD or YELLOW center logo with handle vane greater than 0.125 inches in thickness at the top edge
- (e) If the buckle meets one or more of the conditions in step (d), the following actions are required :
- 1 Remove the buckle assembly and return to Parker Meggitt for Overhaul/SB Application. Refer to paragraph 4.D. for disassembly.
  - 2 Remove the restraint assembly and return to Parker Meggitt for Overhaul/SB Application.
  - 3 Replace the buckle assembly or restraint assembly with a spare, new, or repaired compliant buckle assembly or restraint assembly.
  - 4 Contact Parker Meggitt for return instructions.

**SUSPECT HANDLE**

**ACCEPTABLE HANDLE:  
LESS THAN OR  
EQUAL TO 0.125 INCH**
