SERVICE BULLETIN

CHAPTER 25 - EQUIPMENT/FURNISHINGS

Information Regarding Screw Inspection for the

with PNR 1111548-01 Rotary Buckles

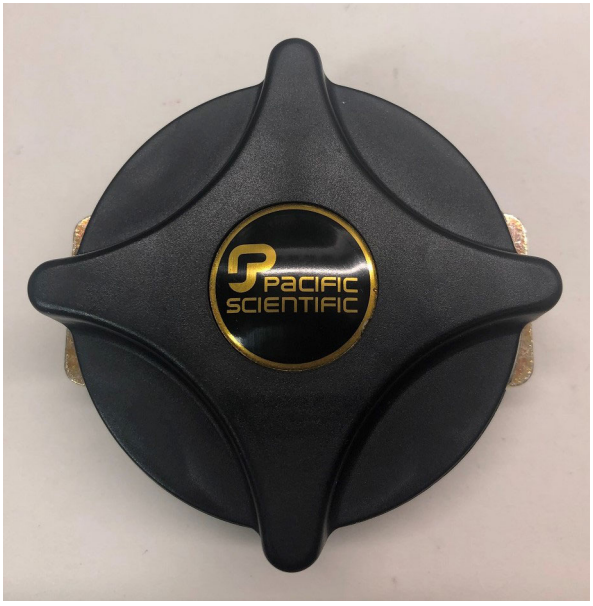
Figure 1
PNR 1111548-01 Rotary Buckle

(1) In 2012 a specific lot of PNR 0901101-123 screws were improperly zinc chromate plated. The manufacturing issue resulted in the screws becoming brittle. Evidence has shown that the screw heads can break-off under load creating an unsafe condition and improper function of the Rotary Buckle used on the Restraint System.

(3) Parker Meggitt has received field reports of cracked and missing screw heads. Figure 1 on page 6 shows a disassembled rotary buckle PNR 1111548-01 with potentially suspect Torx head screws.

1 Buckles which have the suspect Torx head screws (PNR 0901101-123) that are still intact, should have the screws replaced with the hex head screws (PNR 0901101-149) per the instructions in this SB at a time convenient to the operator.

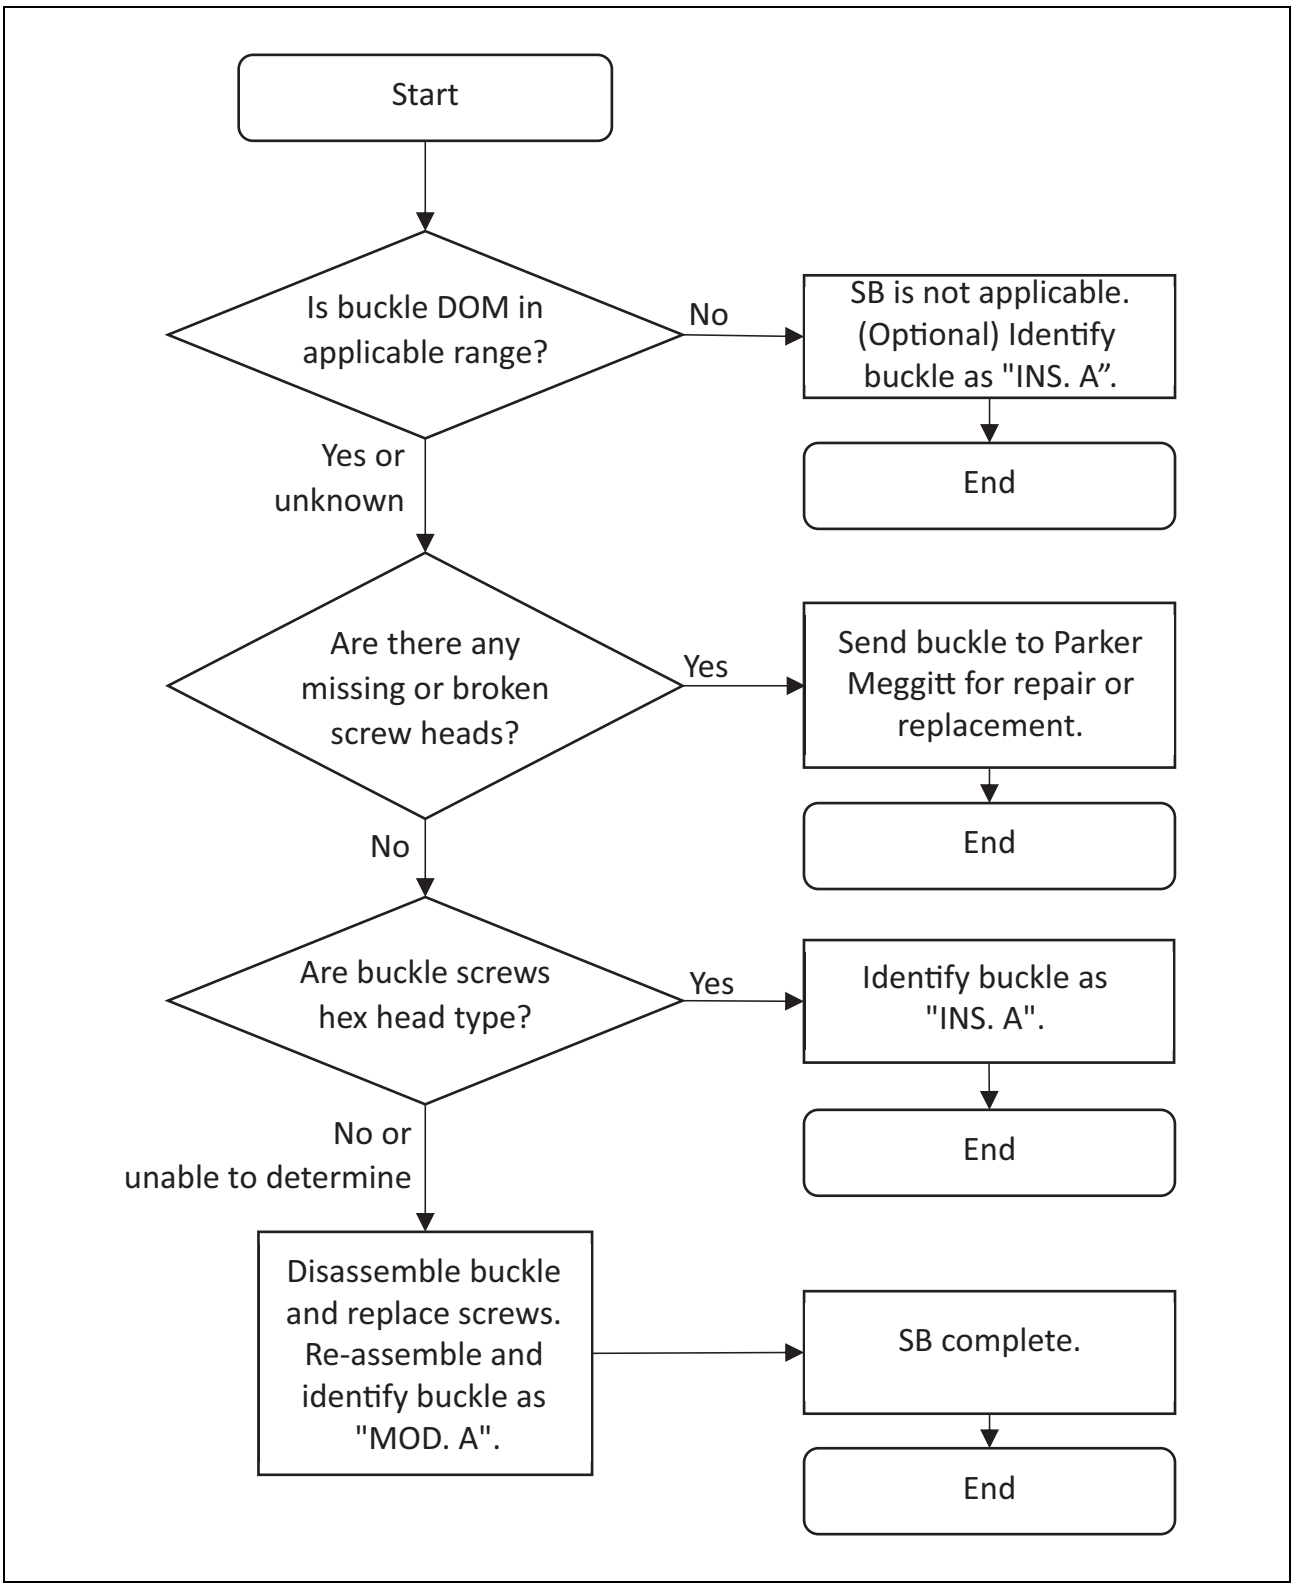
Figure 2
Flowchart of Required Operator Action

(a) Refer to the flowchart in Figure 2 on page 9.

NOTE : Any buckle assemblies with a missing screw head should be removed from service immediately.

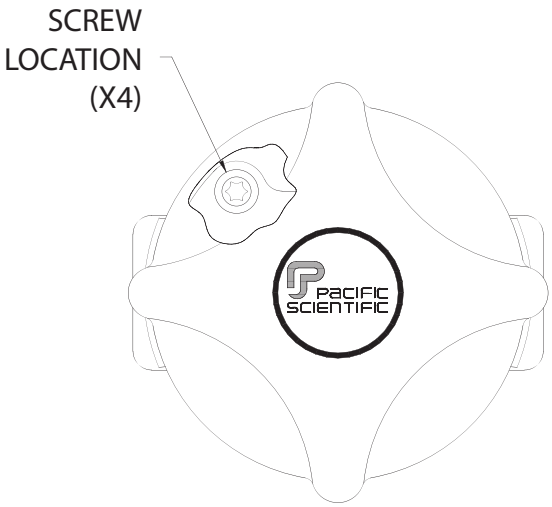
Figure 3
PNR 1111548-01 Rotary Buckle Screw Location

(1) Use an inspection light (100+ lumens light with eye loupe recommended) and shim to look between the handle and the housing for the presence of two screw heads on both the left side and the right side of the buckle. Refer to Figure 3 on page 16 and Figure 4 on page 16.

(a) Remove the buckle from service immediately. Refer to the procedure in section C. to remove the buckle from the restraint system.

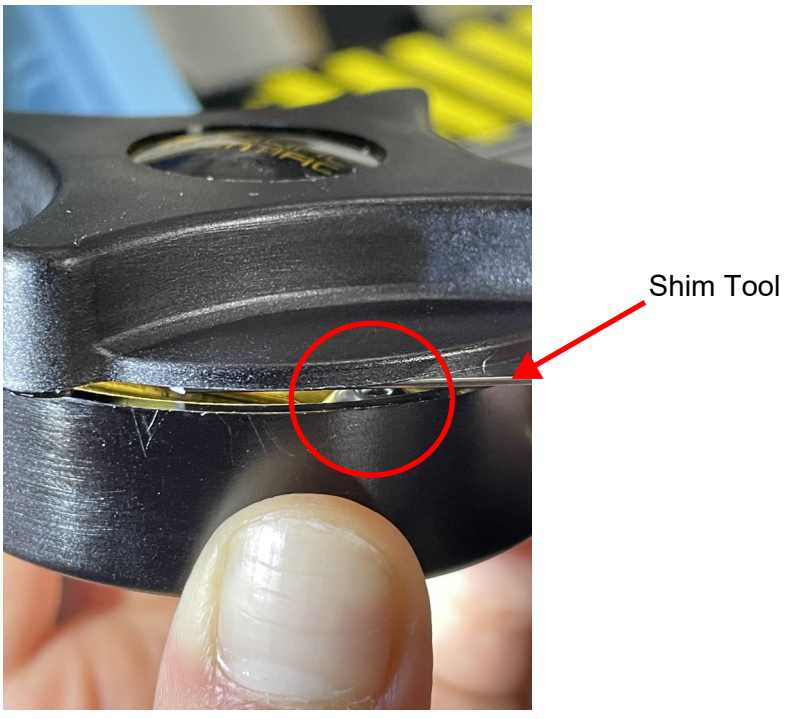
Figure 4
Side Belt Opening Inspection

1 Use an inspection light (100+ lumens light with eye loupe recommended) and shim to look through the aperture between the handle and the non-rotating portion of the buckle (Figure 4 on page 16) and inspect the screws to determine whether they have Torx heads or hex heads. Refer to Figure 5 on page 17 to distinguish the screw head types.

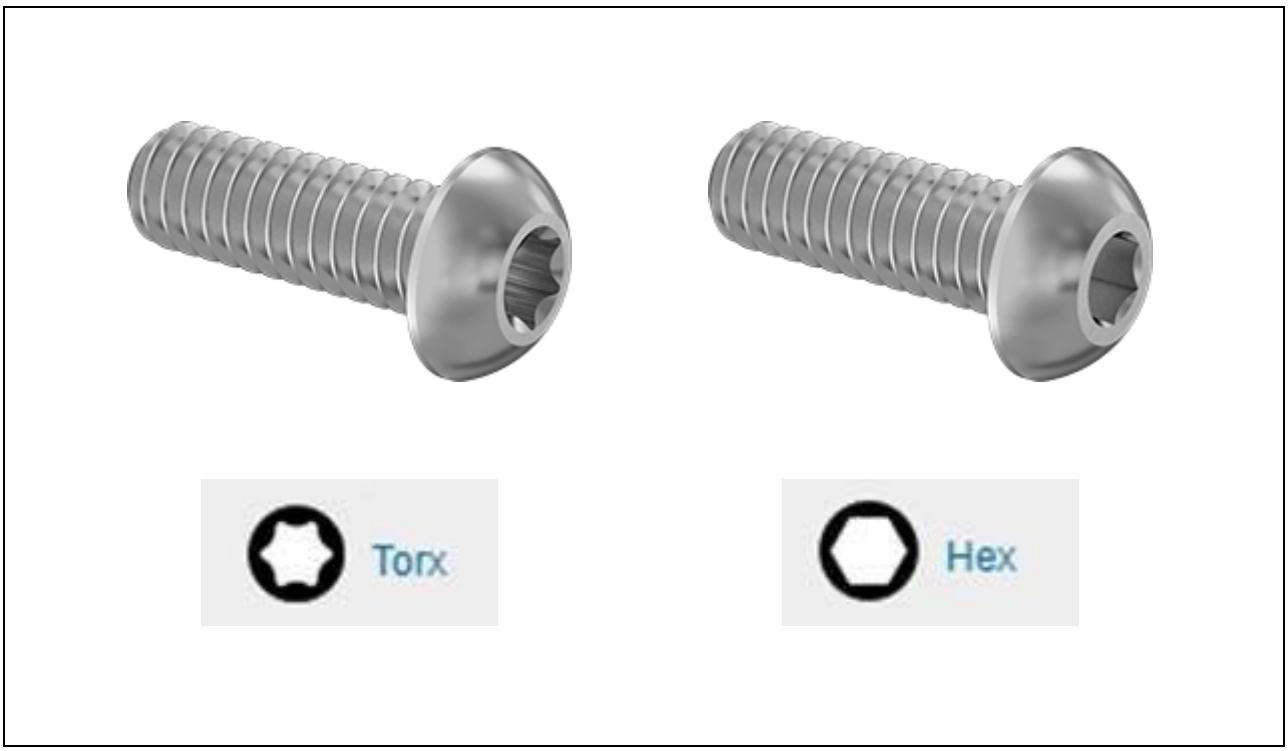
Figure 5
Torx Head Screws vs. Hex Head Screws

NOTE : Zinc chromate plated screw head type does not relate to the susceptibility to cracking. A design change replaced the zinc chromate plated screws (PNR 0901101-123) with stainless steel screws (PNR 0901101-149) that do not require zinc chromate plating. The new screws happened to have a hex head instead of a Torx head.

(4) If the screws have Torx heads (PNR 0901101-123), the buckle may remain in service temporarily, but the screws should be replaced as convenient to the operator. Refer to the procedure in section 4.D. to replace the screws.
