REVISION 003  
dated Sep 24/25

## SB 25-1111432

## **SERVICE BULLETIN**

#### **Information Regarding the Potential Failure of the Guarded Rotary Buckles with Plastic Handles PNR 1111430-XX and PNR 1111475-XX**

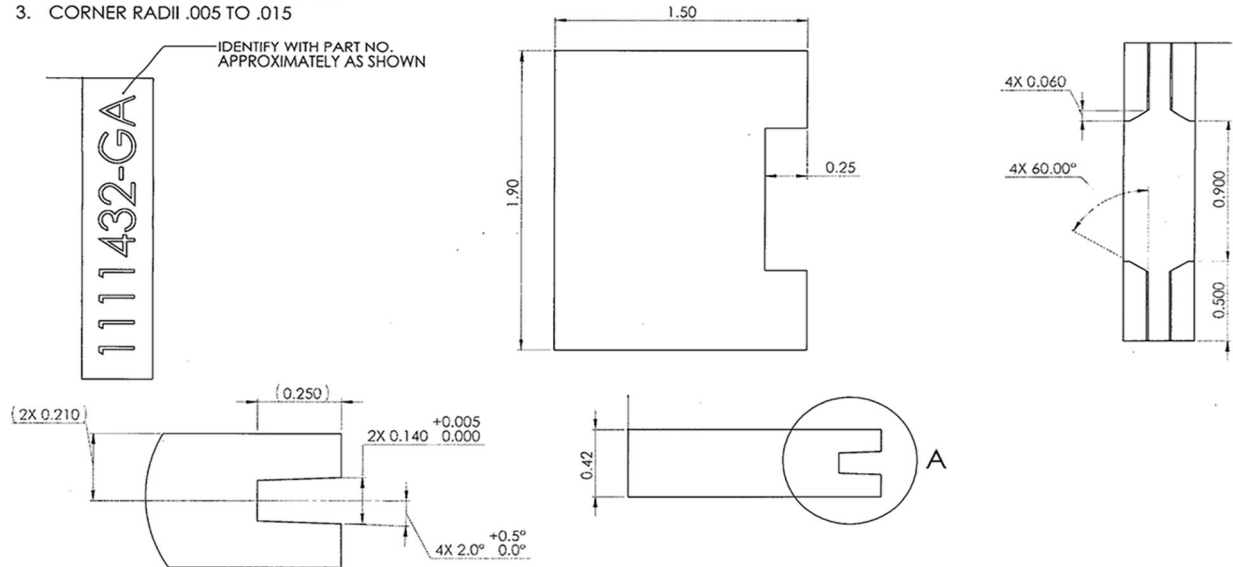
**Figure 5**  
*Optional Inspection Tool PNR 111432-GA*

- (1) Measure the handles in accordance with Figure 3 on page 20 and Figure 4 on page 20 to make sure the handles are less than 0.125 inches at the top edge. Parker Meggitt has created an optional inspection tool (PNR 1111432-GA). Contact Parker Meggitt for purchase of the inspection tool. Refer to Figure 5 on page 21 for correct use of the optional inspection tool.

## OPTIONAL INSPECTION TOOL FITS OVER VANES CENTER IS FLUSH TO BUTTON
