SERVICE BULLETIN

Information Regarding Screw Inspection for the

Restraint Systems

with PNR 1111475 Series Rotary Buckles

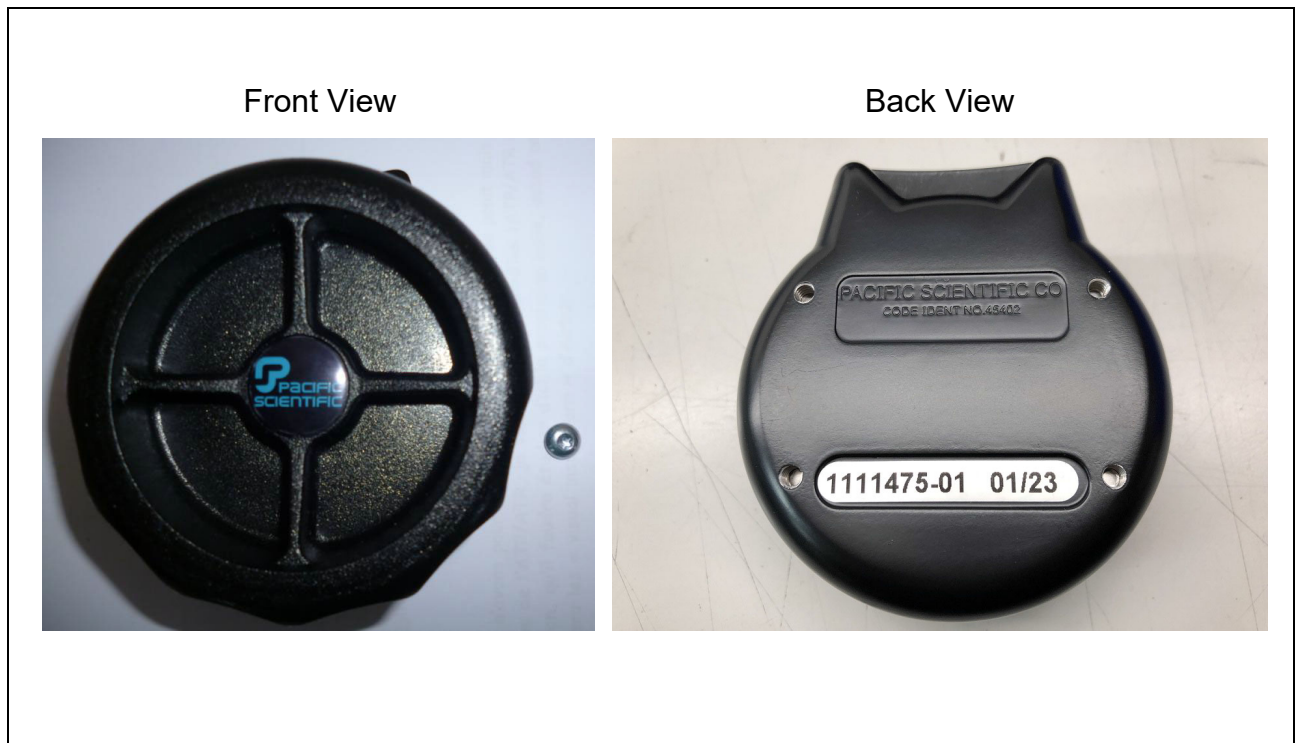
Figure 1
PNR 1111475 Series Rotary Buckle and Broken Screw Head

- (1) In 2012 a specific lot of PNR 0901101-123 screws were improperly zinc chromate plated. This manufacturing issue resulted in the screws becoming brittle. Evidence has shown that the screw heads can break-off under load creating an unsafe condition and improper function of the rotary buckle used on the restraint system.
- (2) Screws (PNR 0901101-123) used on rotary buckles (PNR 1111475 Series) are susceptible to premature failure of the screw.
- (3) Parker Meggitt has received field reports of cracked and missing screw heads. Figure 1 on page 7 shows an example of a PNR 1111475 Series buckle with a broken screw head.

This image is for reference only. In most cases, the broken screw head will be missing and not immediately obvious. Inspection per section 4.B. is required to determine whether a buckle has broken screws.

- 1 Buckles which have any missing screws should be taken out of service immediately. Replace the rotary buckle with a spare compliant rotary buckle and send the broken item back to Parker Meggitt for repair or replacement (refer to section 4.F.).

- (e) If the rotary buckle has a broken/loose screw head, the rotary buckle should be removed from service immediately.
 - 1 Replace the rotary buckle with a spare compliant rotary buckle and send the broken item back to Parker Meggitt for repair or replacement (refer to section 4.F.).

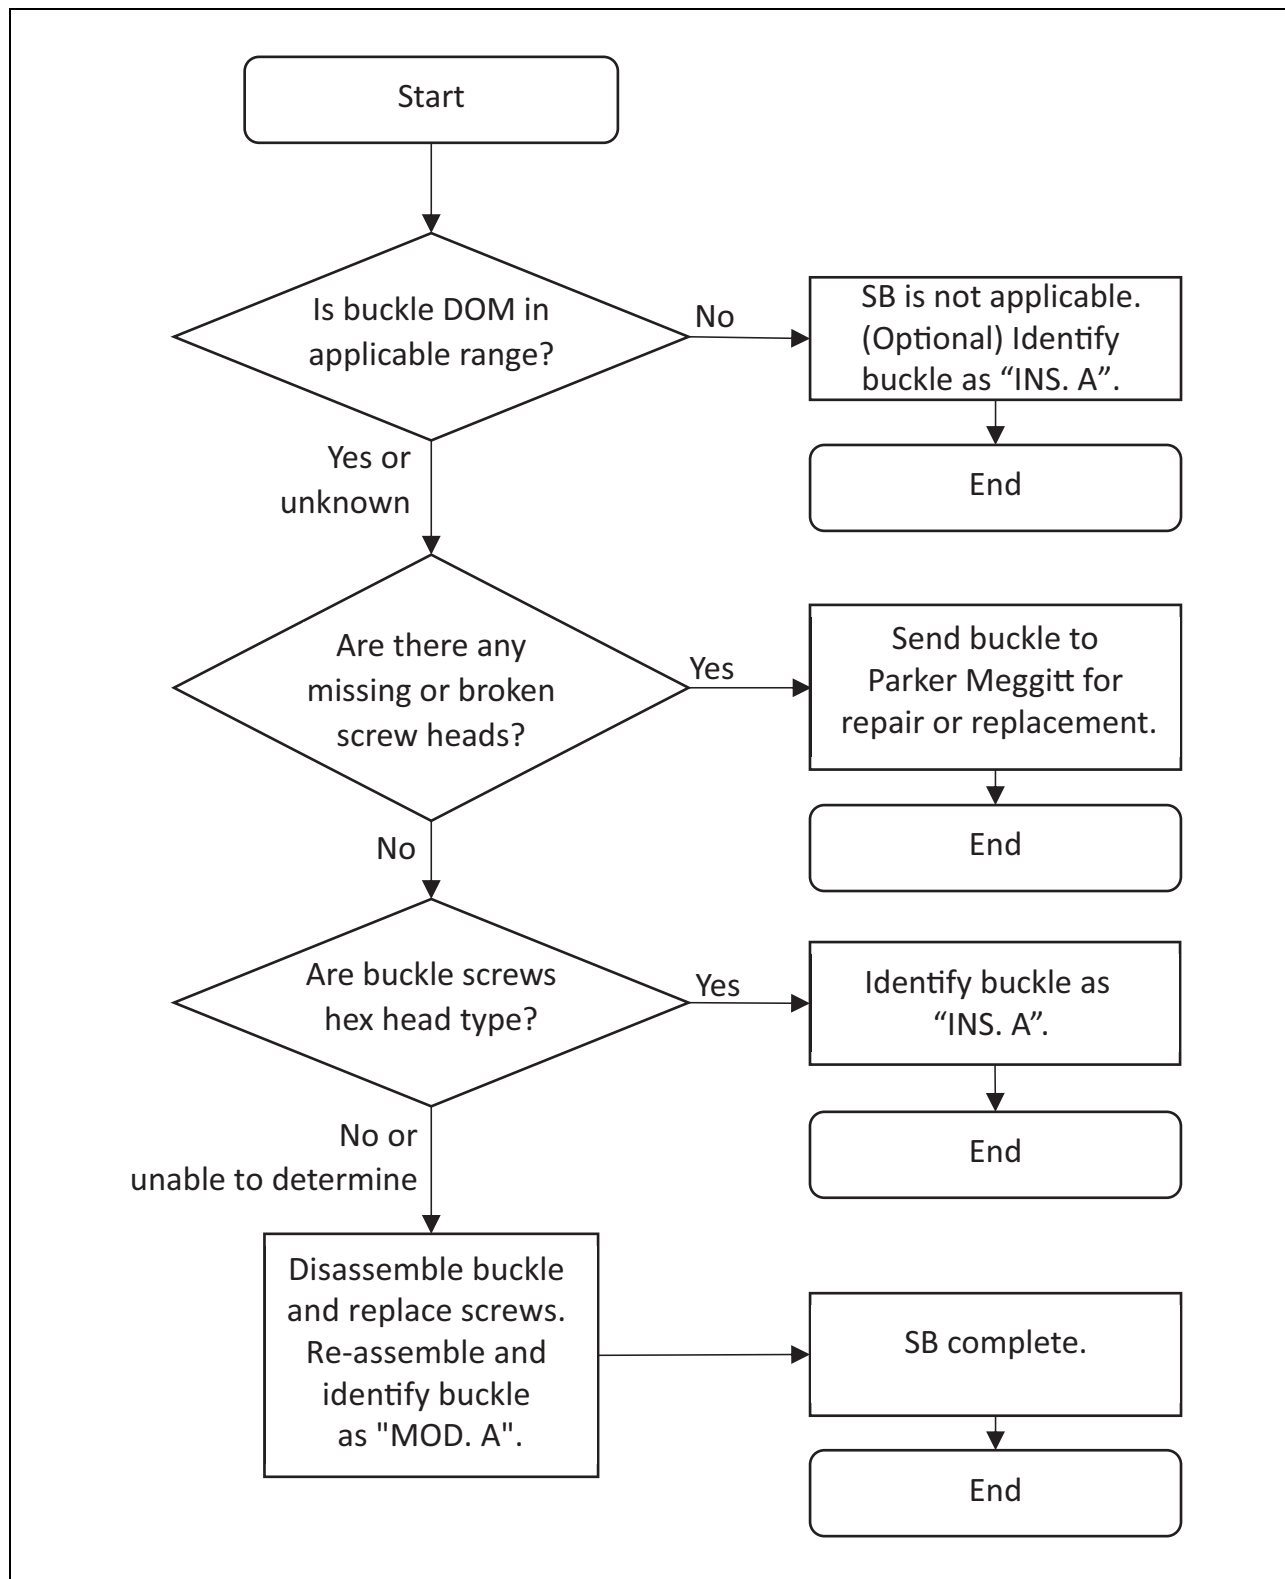
Figure 2
Flowchart of Required Operator Action

- (a) Refer to the flowchart in Figure 2 on page 10.
- (b) Operators should check all restraint systems and buckle assemblies in service and inventory that meet the criteria in sections 1.A. & 1.B. This also applies to restraint systems in storage or any restraint system that may have had a buckle replaced with one of these part numbers, or that may have been repaired using the suspect screws.

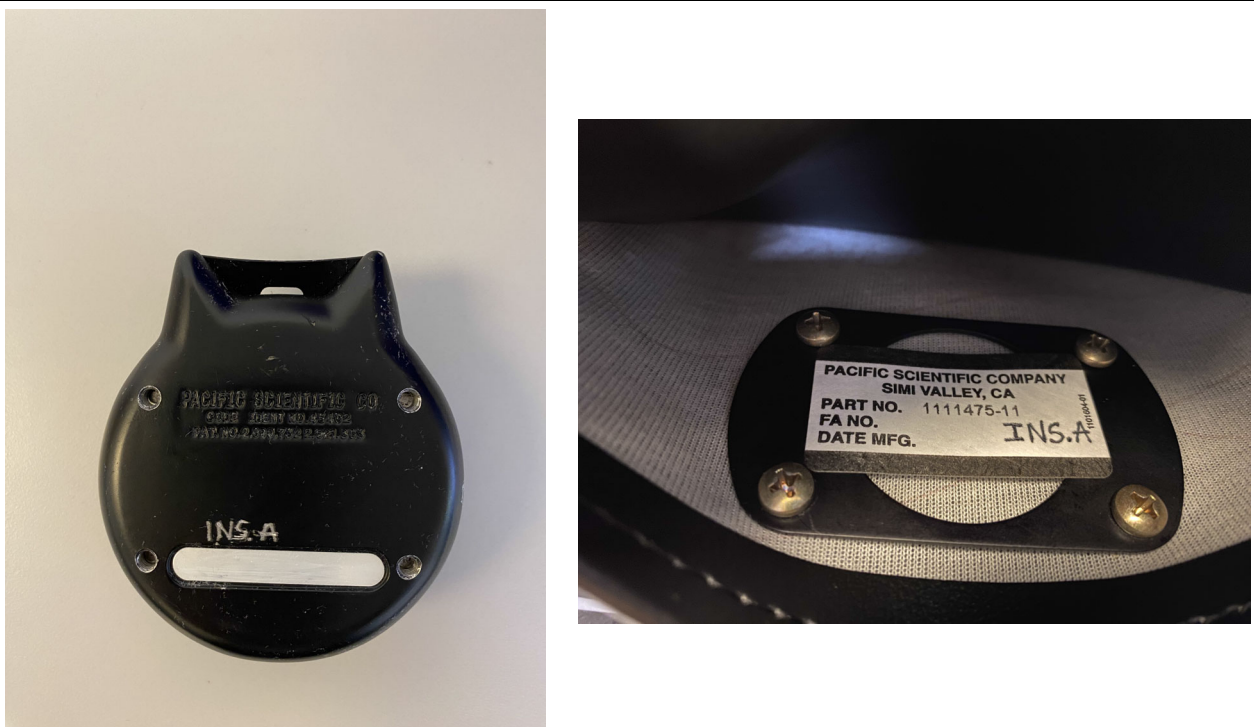
Figure 10
Re-Identified PNR 1111475 Series Rotary Buckle Assembly with "INS. A"

- (a) Use a vibro engraving pen to engrave **"INS. A"** on the back of the buckle. If the buckle has a pad, use an ultra-fine permanent marker to mark **"INS. A"** on the label inside the buckle pad. Refer to Figure 10 for an example of the re-identified buckle and the location of the label for the buckle pad.

- (1) Before removing the rotary buckle from the restraint system, make sure the rotary buckle is identified (refer to Figure 10). If the rotary buckle is not identified, the rotary buckle should either be "Bag and Tagged" with restraint system upon removal or re-identified (refer to 4.B.(7) on page 20).

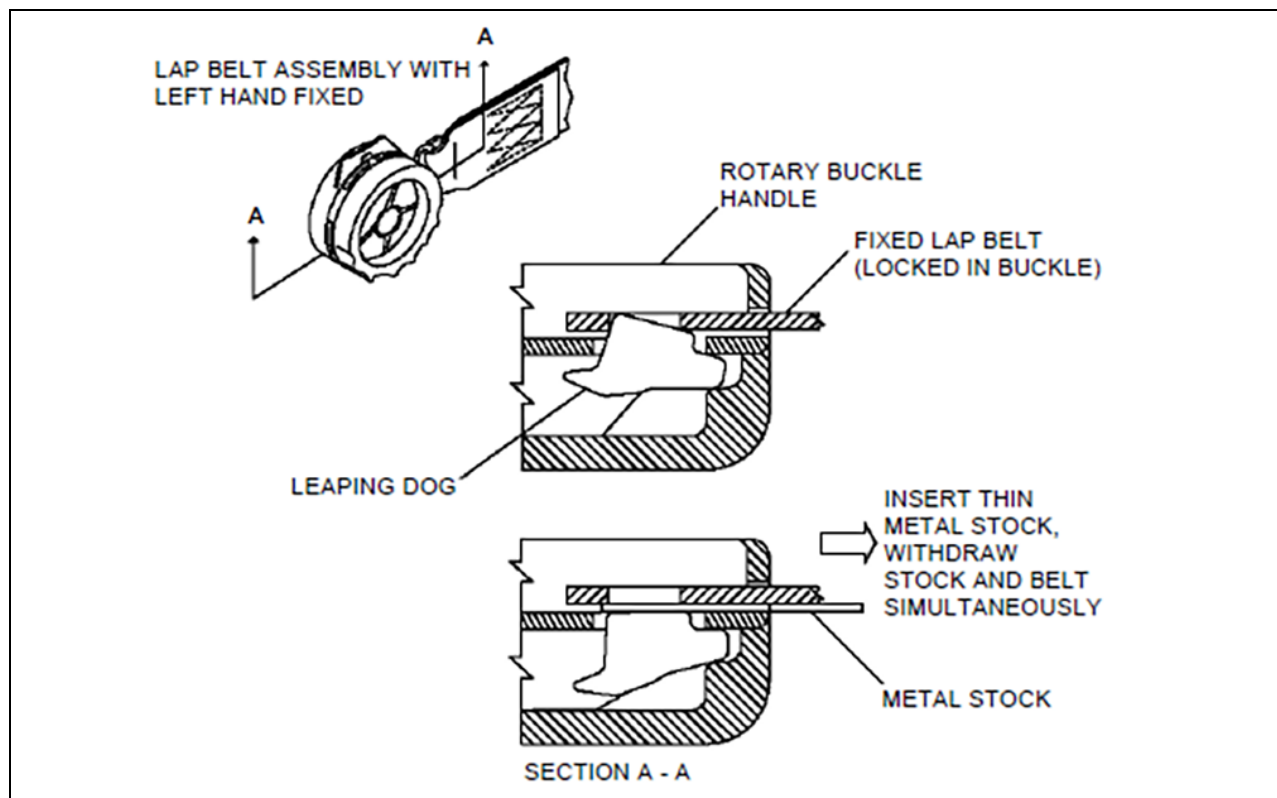
Figure 11
Removal of Rotary Buckle

- (2) Refer to Figure 11.
- (3) Insert a piece of thin metal stock or shim into the slot of the rotary buckle and push inward between the fitting and the buckle locking mechanism.
- (4) Pull the fitting from the buckle.

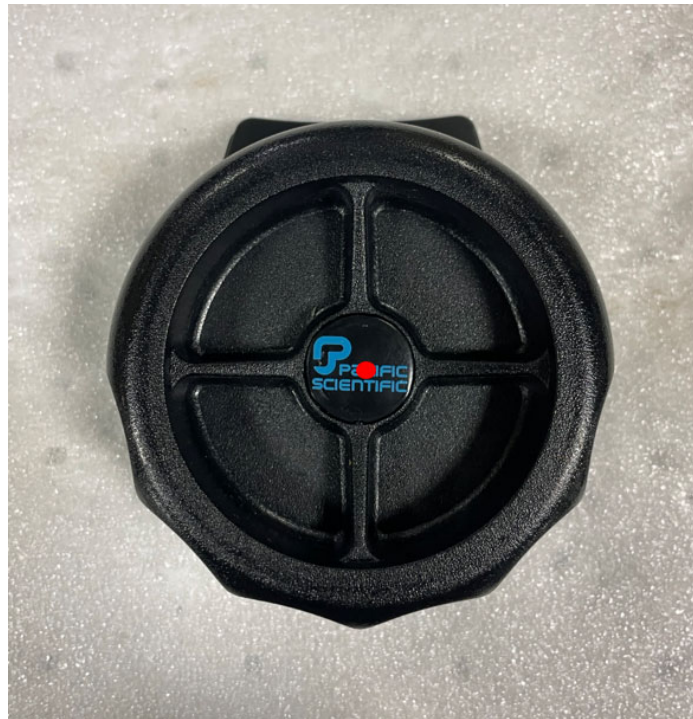
Figure 12
Logo Button Optimal Pierce Location

- (a) Use a pry tool to pry the nameplate button (PNR 1101813-01) free from the buckle. If necessary, pierce the middle of the button (button is soft material). Try to damage the button as little as possible so that it can be used again.

NOTE : An example of the optimal pierce location is shown with a red dot in Figure 12.

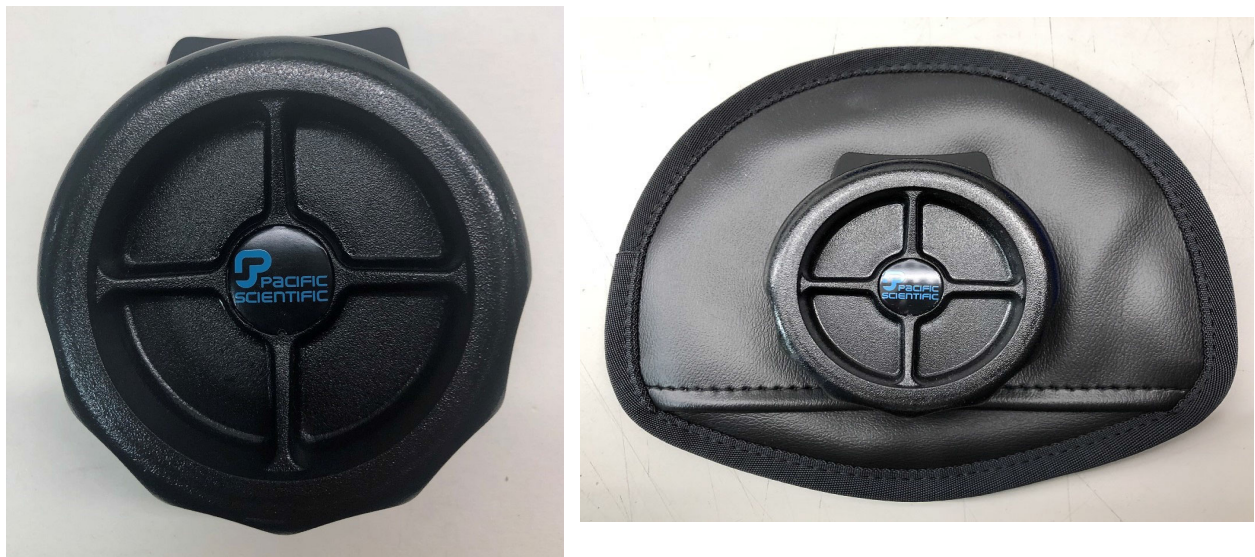
**Figure 14***PNR 1111475 Series Rotary Buckle Logo Button Alignment***SB 1111475-25-001-2023**

- (j) Put the buckle in an arbor press or equivalent tool. Put the logo on the center of the buckle, with the "PACIFIC SCIENTIFIC" text levelled evenly with the two plates.

- NOTE : An example of the alignment can be seen in Figure 14.
- (k) Hold a 7/16 inch [11 mm] socket in place on the button. Use arbor press or equivalent tool to press the button in place on the buckle.

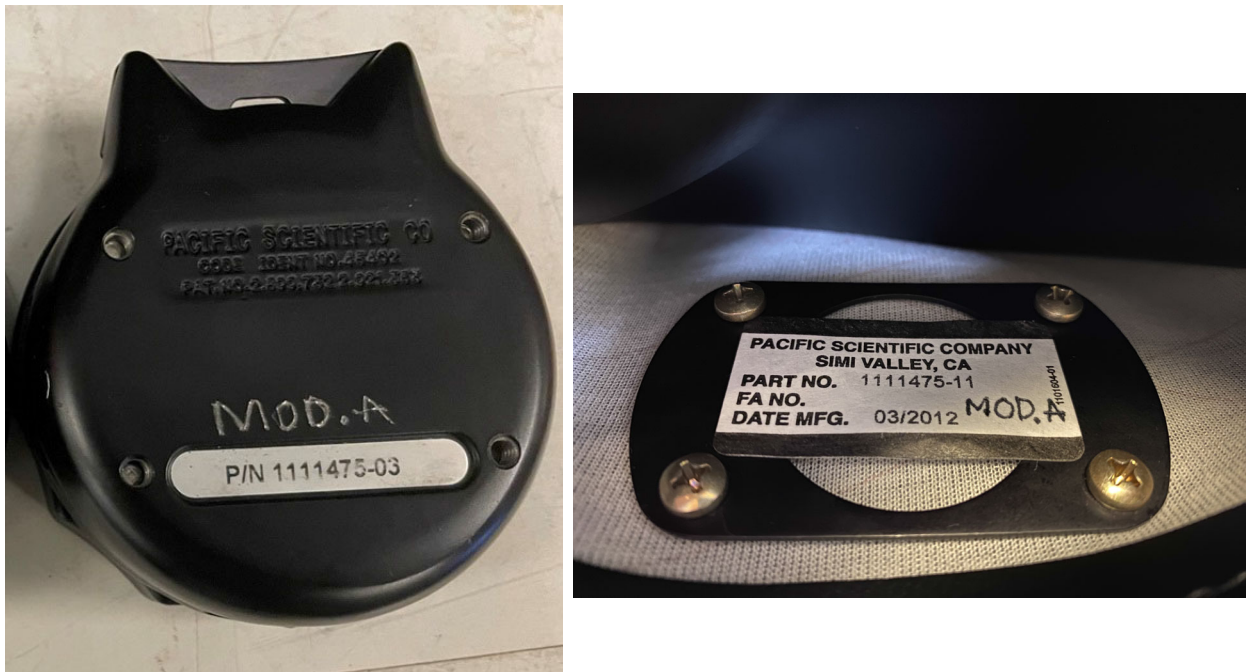
Figure 15
Re-Identified PNR 1111475 Series Rotary Buckle Assembly with "MOD. A"

- (1) Buckles with the new screws installed shall be identified as "**MOD. A**". Refer to 4.D.(1).(m) on page 26 for the marking process for each buckle.
- (2) Buckles that have been inspected and found to have the stainless steel screws with the hex head installed shall be identified as "**INS. A**". Refer to 4.B.(6) on page 20 for the marking process for each buckle.
- (3) Removed buckles with missing part number shall be marked. Refer to 4.B.(7) on page 20 for marking process and refer to Table 1 on page 3 for part numbers of the restraint systems and related rotary buckles.
